Reserve Study Project No. 10108

Prepared for
Weatherstone at Highlands Ranch Association
Highlands Ranch, Colorado

Prepared by
Bornengineering
8310 South Valley Highway, 3rd Floor
Englewood, Colorado 80112

May 2, 2011

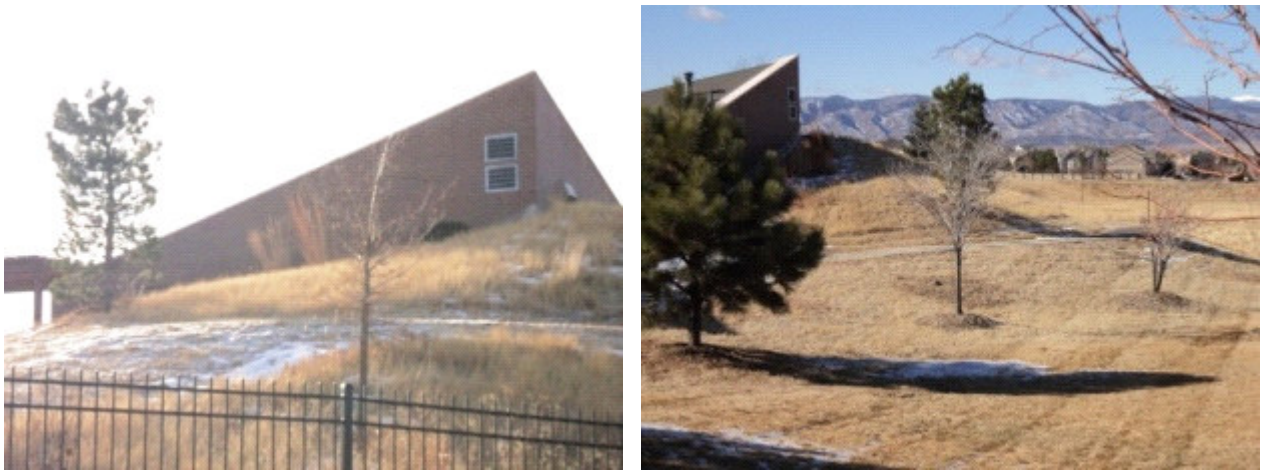
Condition: Satisfactory condition with some deterioration and damage noticed. Several areas of soil near the building foundation appear to have settled, producing negative slope routing stormwater toward the foundation or neutral slope allowing water to pool and settle around the building foundations. A minimal number of areas throughout the site drainage system display the same characteristics as the building grading and drainage system.

- Cyclically re-grade a portion of the surface slope every 7 years, starting in 2016.

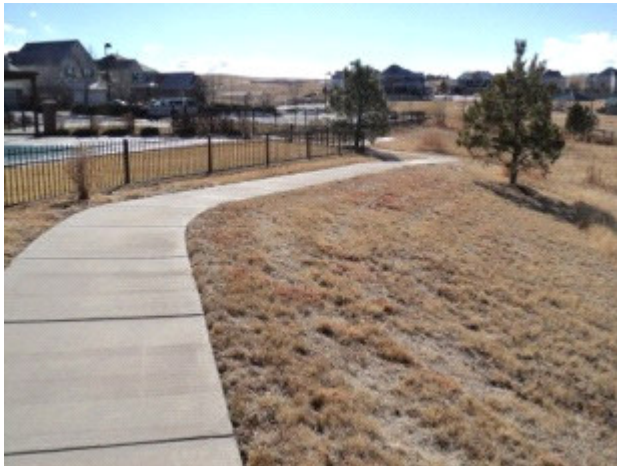
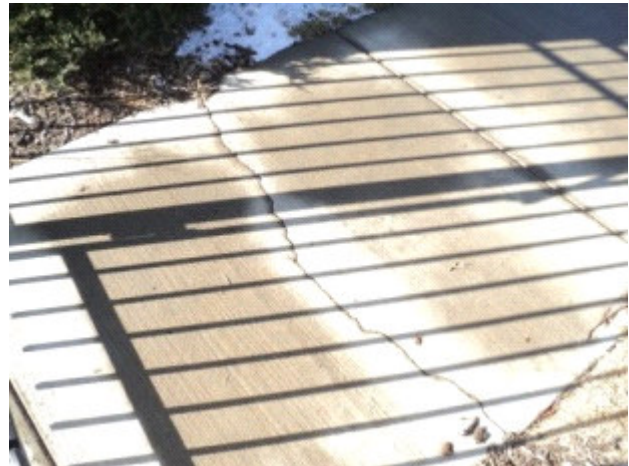
B1. Walkways

Condition: Satisfactory condition with some deterioration and damage noticed. Some of the walkways have experienced pressures causing cracking or displacement within the control joints and a minimal amount of cracking through the field of the walkway. One joint has lifted and could be a potential trip hazard. We were informed that none of the flatwork has been replaced, thus we extended the replacement cycle from three years to six years.

- Cyclically replace damaged sections of the walkways every 6 years, starting in 2017.

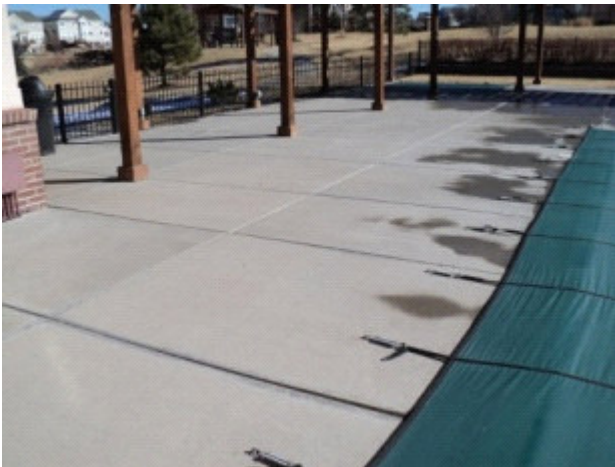
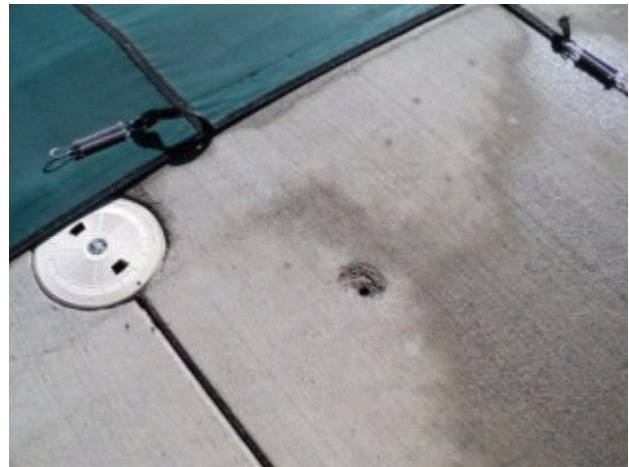
B2. Pool Deck

Condition: Satisfactory condition with some deterioration and damage noticed. During the site visit some damage was observed at the surface of the pool deck. It appears that the anchors used to fasten the pool cover have broken away from the pool deck and have left pits in the concrete with exposed aggregate.

- Cyclically repair or replace damaged sections of the pool deck every 6 years, starting in 2015.

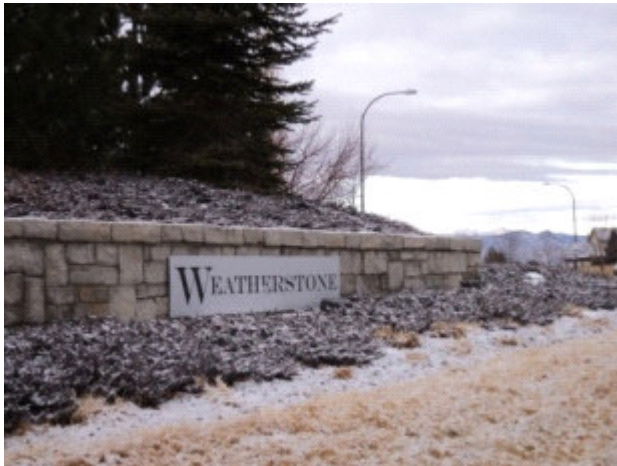
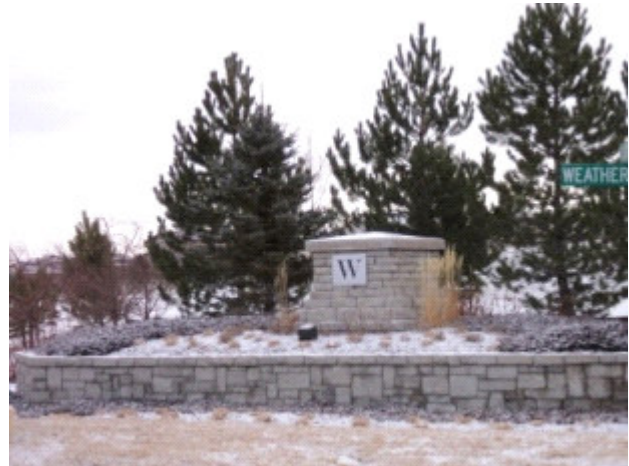
C1. Entrance Monuments

Condition: Satisfactory condition with some deterioration and damage noticed. Some stones have been displaced and the mortar is severely deteriorated at the joints between the masonry units. This is especially apparent at the east monuments.

- Cyclically tuck-point and repair the stone veneer at the entrance monuments every 10 years, starting in 2011. Financial allocation for the repair of the entrance monuments is included in component D2 of this Study.

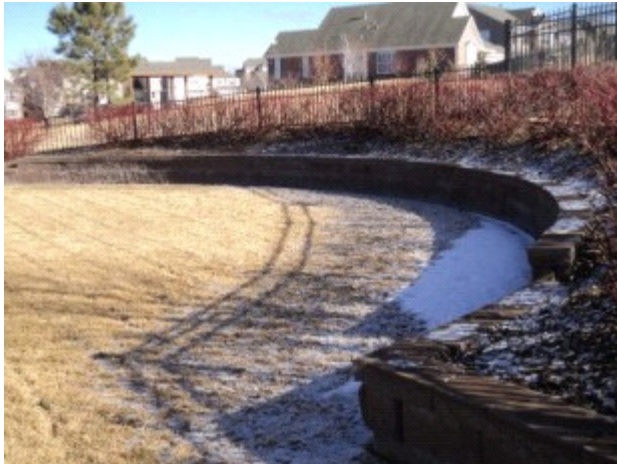
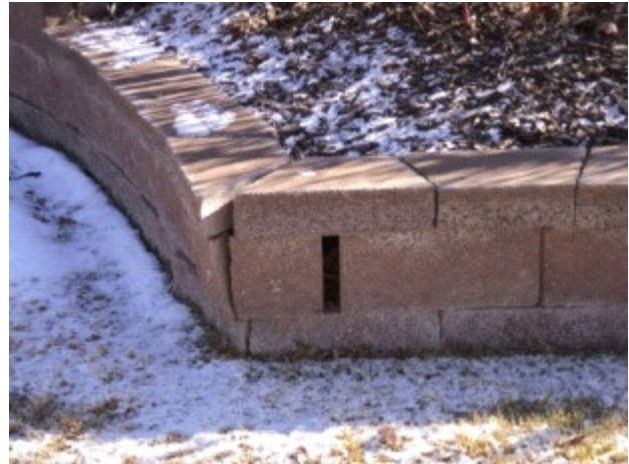
C2. Block Retaining Wall

Condition: Satisfactory condition with some deterioration and damage noticed. During the site visit, extensive displacement was observed in a couple of areas at the south end of the wall.

- Cyclically repair the retaining walls and regrade the soil surrounding them every 7 years, starting in 2011. The cost is not included in the Study because it falls below the minimum fund threshold.
- Replace the block retaining wall in 2048. The life expectancy of the block retaining wall should exceed the term of this Study.

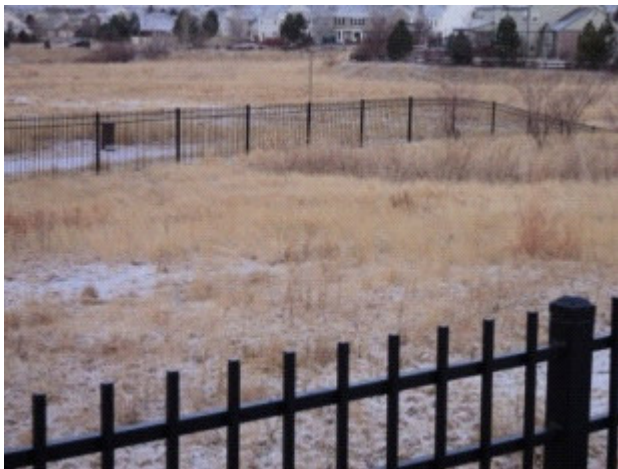
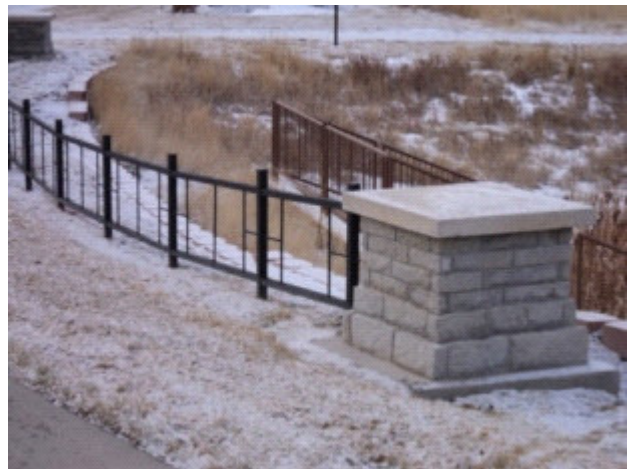
C3. Metal Fence

Condition: The metal fence surrounding the pool area appears to be in good condition with minimal deterioration and damage noticed. During the site visit, we were informed that the metal fence in was prepped and painted in 2010. The paint on the decorative metal fence along Weathers Field Way and Stone Mountain Drive is weathering and resulting in deterioration of the metal. The horizontal surfaces of this fence show the most deterioration.

- Finish repairing and painting the metal fence at the entry thoroughfares in 2011.
- Cyclically repair and paint fence every 5 years, starting in 2015.
- Replace the metal fence in 2023.

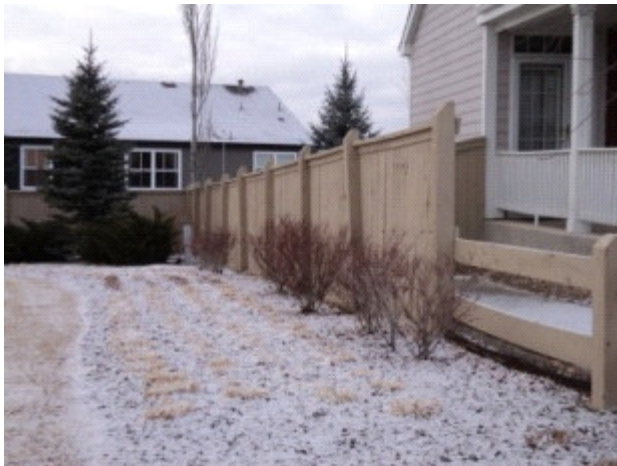
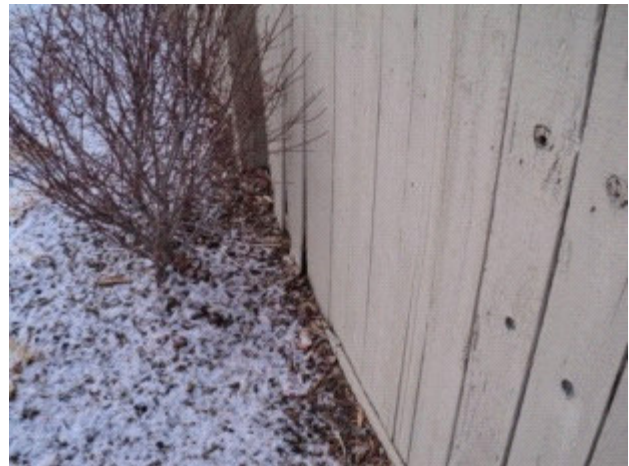
C4. Privacy Fence

Condition: Satisfactory condition with some deterioration and damage noticed. During the site visit, it was noticed erosion from the private lots is causing displacement along the bottom perimeter of the fence. We were informed that a portion of the privacy fence has recently been repaired and stained.

- Finish repairing and staining the privacy fence at the entry thoroughfares in 2011.
- Replace the privacy fencing in 2017 with composite fencing.

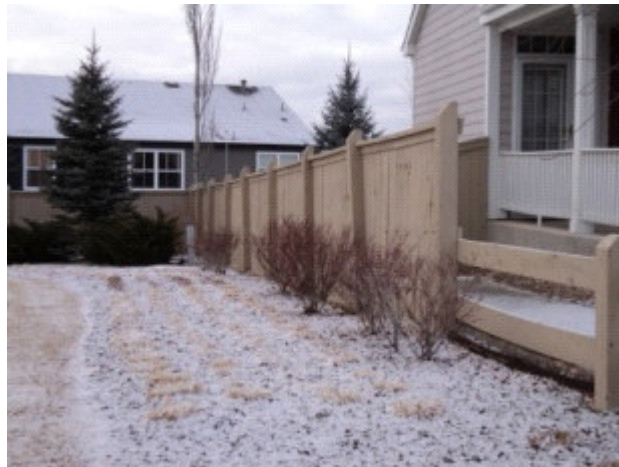
C5. Rail Fence

Condition: Satisfactory condition with some deterioration and damage noticed. During the site visit, a few rails were loose and the stain appears thin in some areas.

- Cyclically replace the rail fence every 15 years, starting in 2016.
- Cyclically repair and stain the rail fence every 5 years, starting in 2021.

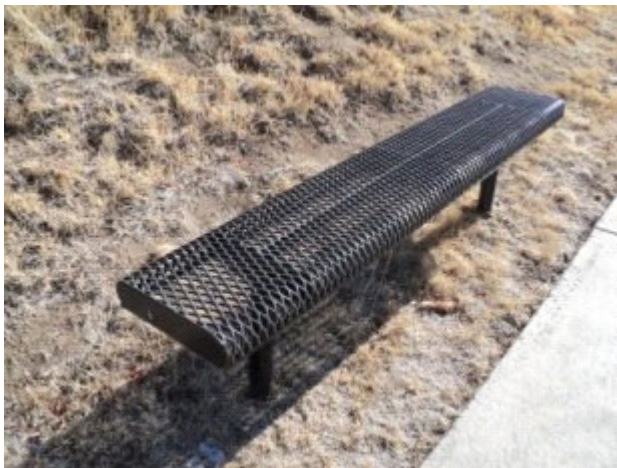
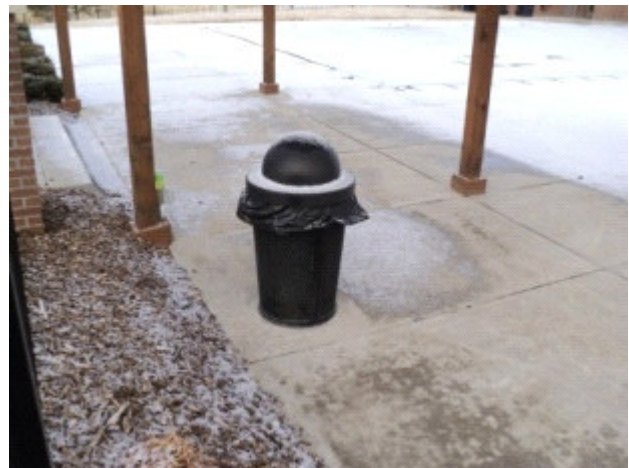
C6. Bench, Trash Receptacles, Picnic Tables and Bike Rack

Condition: All appurtenances appear to be in good condition. Some of the fastening hardware at the above listed items has evidence of corrosion.

- Replace the benches, trash receptacles, picnic tables and bicycle rack in 2018.

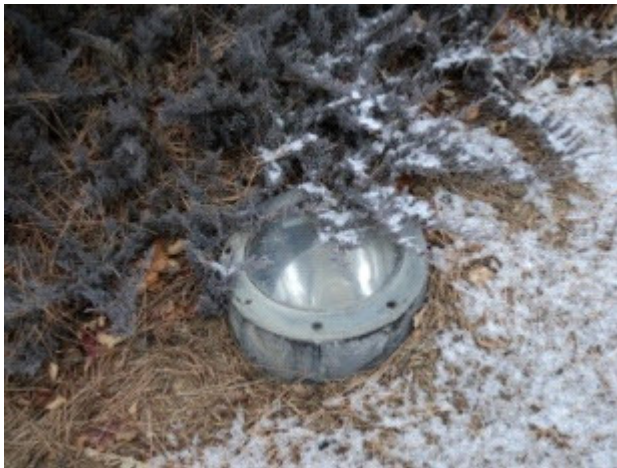
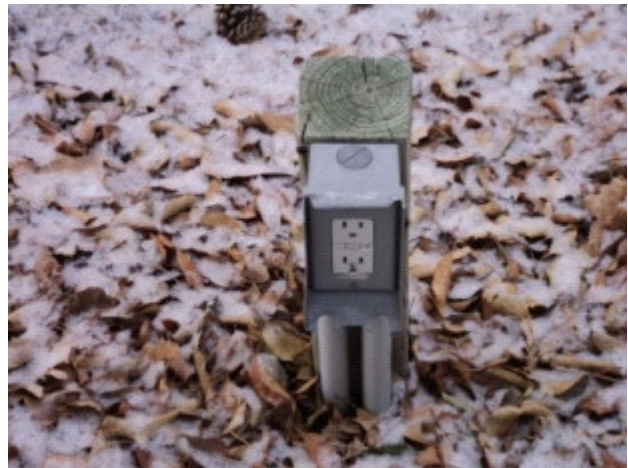
C10. Landscape Electrical Units

Condition: Satisfactory condition with some deterioration and damage noticed. Some of the electrical receptacles have the weather cover broken off and should be replaced immediately. The up lights appear to be in good condition. None of the lights or the electrical outlets were operable during the site visit.

- Cyclically replace the damaged sections of landscape electrical units every year, starting in 2011. The cost is not included in the Study because it falls below the minimum fund threshold.

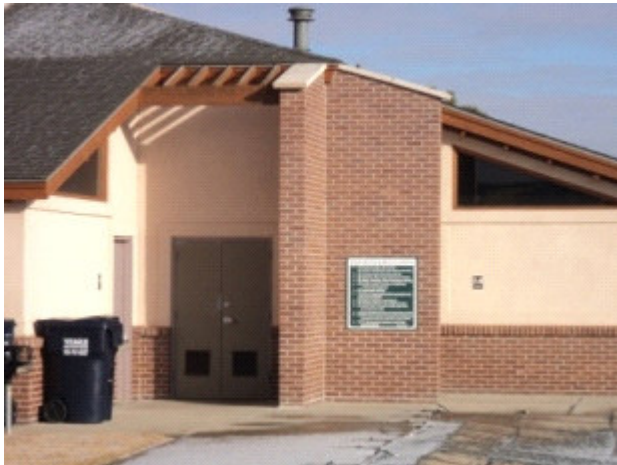
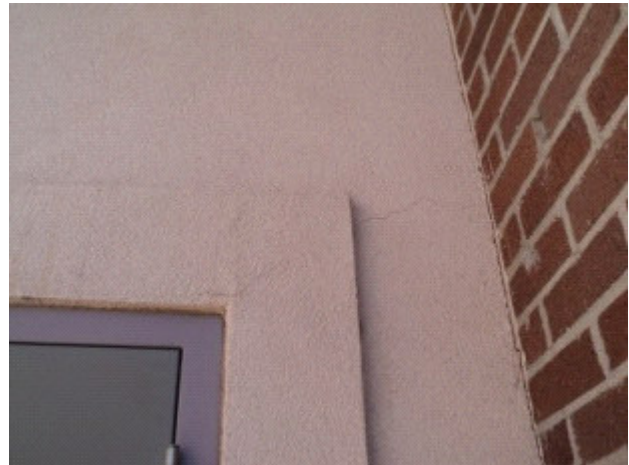
D1. Stucco

Condition: Satisfactory condition with some deterioration and damage noticed. There is minimal surface cracking at the stucco surrounding doors at the pool house.

- Cyclically repair any damaged sections of the stucco every 10 years, starting in 2013.

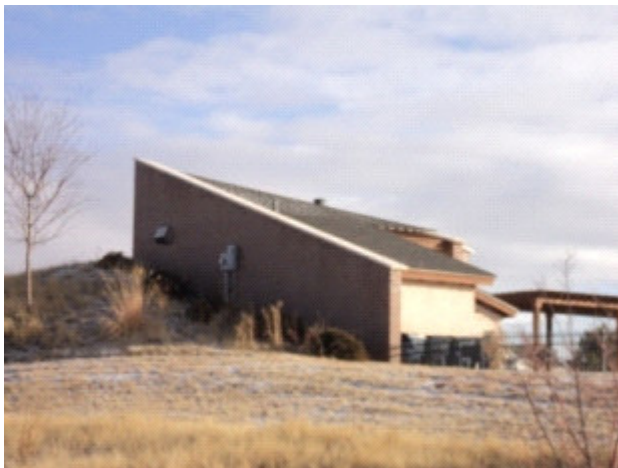
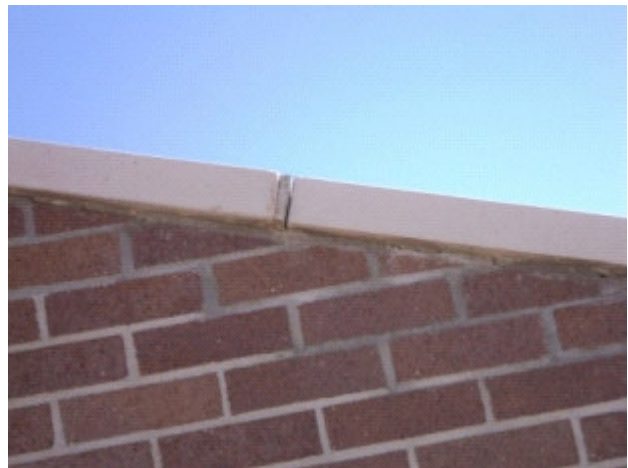
D2. Brick and Stone Veneer

Condition: Poor condition. The masonry units appear in good condition, however the pre-cast caps that top the walls of the pool house are loose and the mortar is displaced. It is recommended to complete repairs as soon as weather allows due to the potential fall hazard and water infiltration. Some of the stone veneer units are displaced at the entrance monuments and the mortar joints are showing extensive indication of deterioration.

- Cyclically tuck-point the mortar joints of the brick, pre-cast and stone veneer units and replace any damaged sections every 10 years, starting in 2011. See condition above.

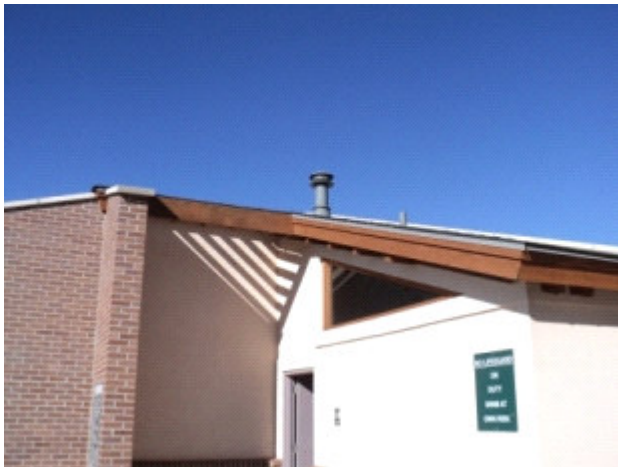
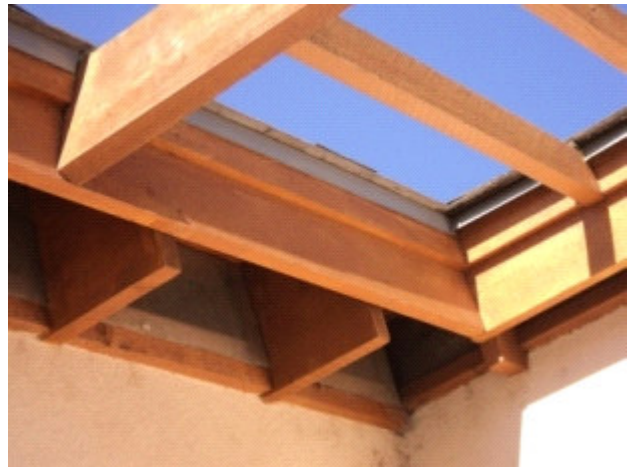
D3. Trim

Condition: Satisfactory condition. During the site visit, we were informed that the wood trim at the pool house was stained in 2009, along with the Trellis. The stain appears thin at some of the components.

- Cyclically repair and stain the trim every 6 years, starting in 2012. Financial allocation for the repairing and staining the pool house Trim is included in component G3 of this Study.

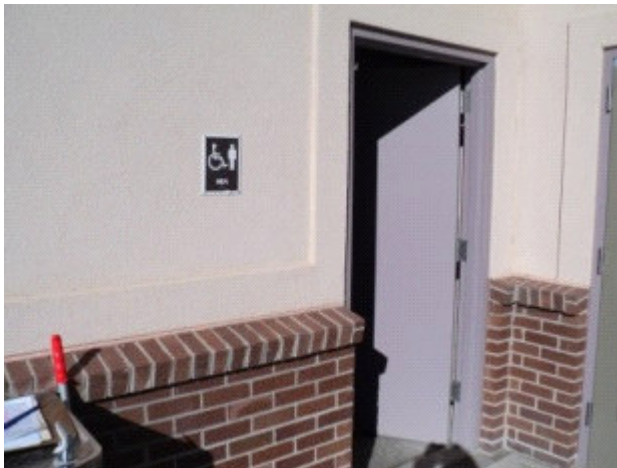
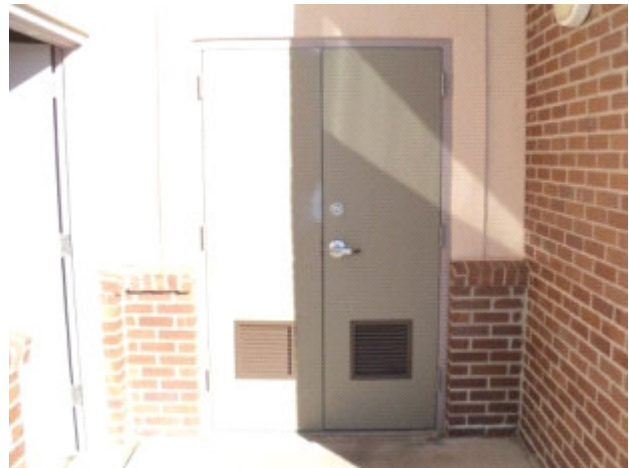
D5. Entry Doors

Condition: Satisfactory condition with some deterioration and damage noticed. During the site visit, we were told the mechanical room doors were replaced in 2010. The doors at the restrooms are displaying some corrosion at the lower portion of the units.

- Replace the restroom entry doors in 2015.

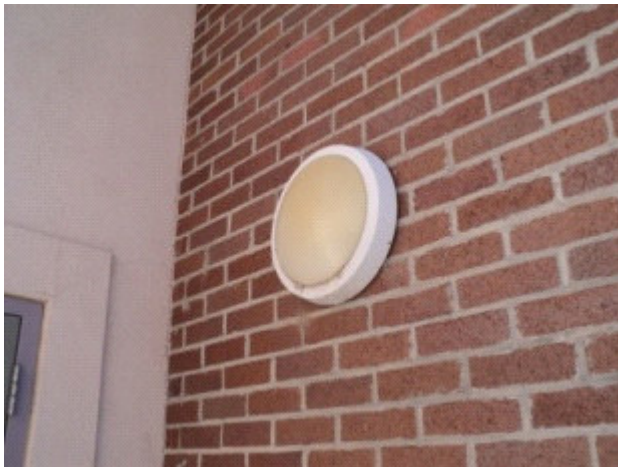
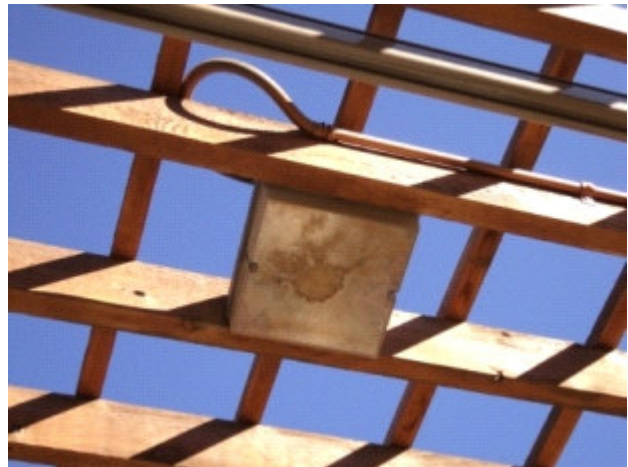
D6. Exterior Lighting

Condition: During the site visit, the lights were inoperable thus only the aesthetic condition could be assessed. The lights at the pool house appear to be in good condition with minimal wear noticed. The lights found at the trellis appear to all have sustained deterioration and water damage to the housings and fasteners.

- Replace the exterior lighting units in 2012.

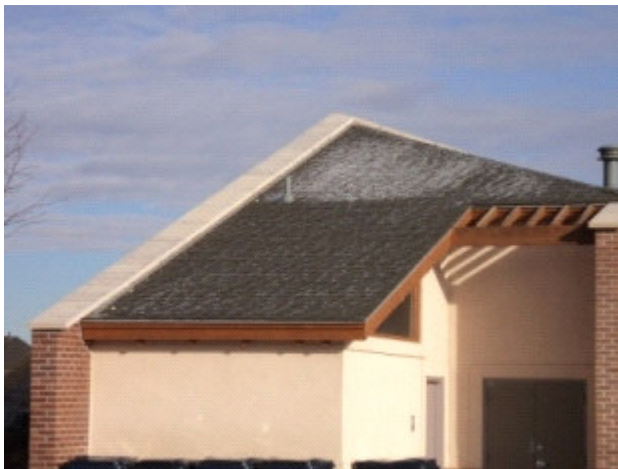
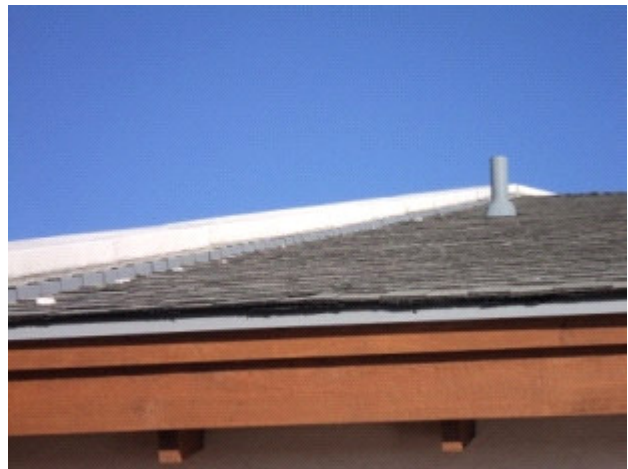
E1. Asphalt Shingles

Condition: Satisfactory condition with some deterioration and damage noticed. The shingles appear to have sustained some damage and deterioration.

- Replace the asphalt shingles in 2013.

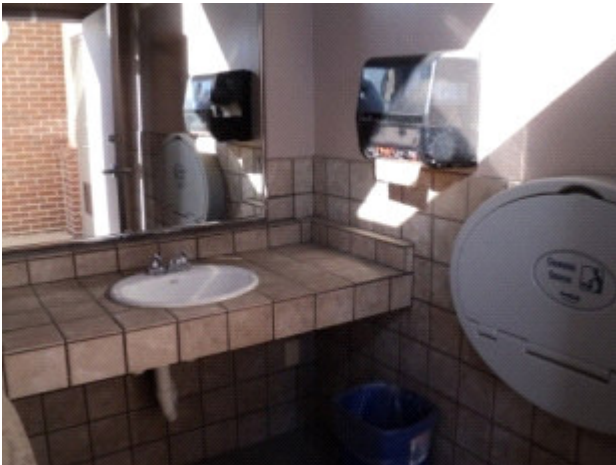
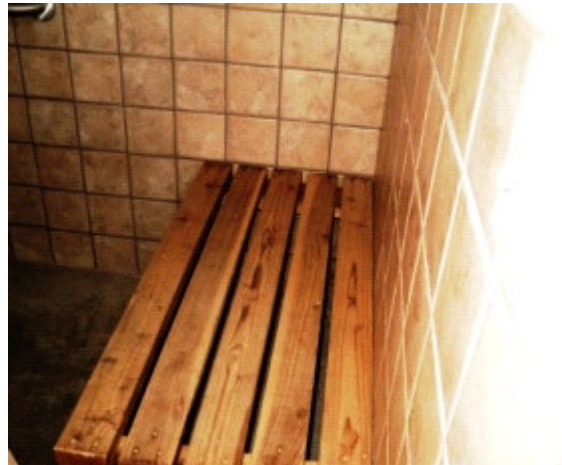
F1. Restrooms

Condition: Satisfactory condition with some deterioration and damage noticed. During the site visit, some of the tile and grout were found displaced.

- Cyclically refurbish the restrooms every 15 years, starting in 2015.

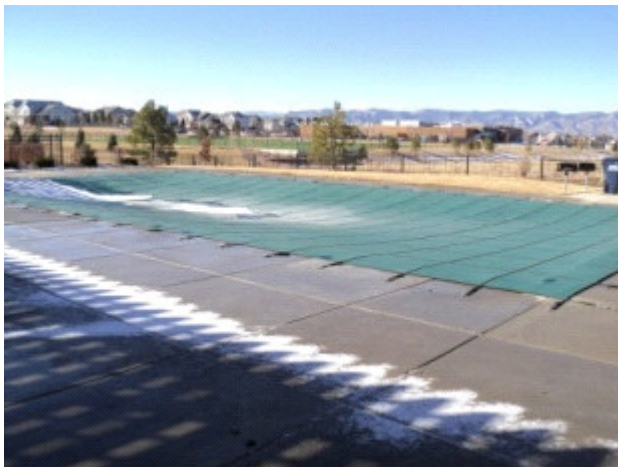
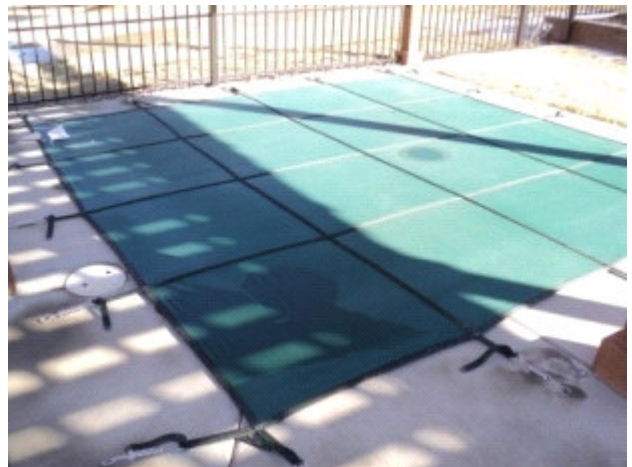
G1. Swimming and Wading Pools

Condition: During the site visit, the pool cover displayed substantial signs of deterioration and damage. We were told that the coping stones and grout around the perimeter of the pool was repaired in 2008.

- Cyclically resurface the pools every 10 years, starting in 2014.
- Cyclically repair or replace the coping stones every 10 years, starting in 2018.
- Cyclically replace the pool covers every 13 years, starting in 2014.

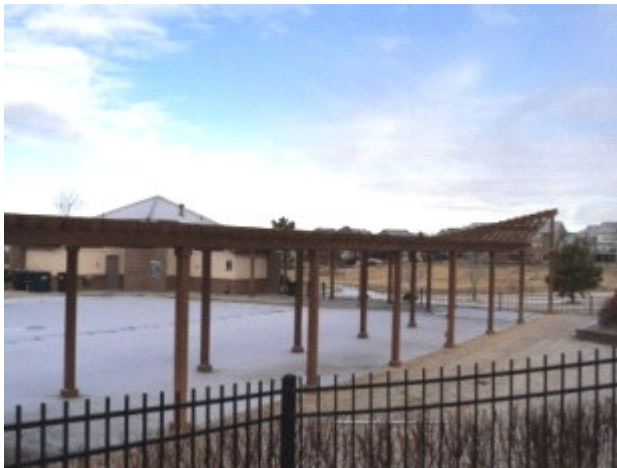
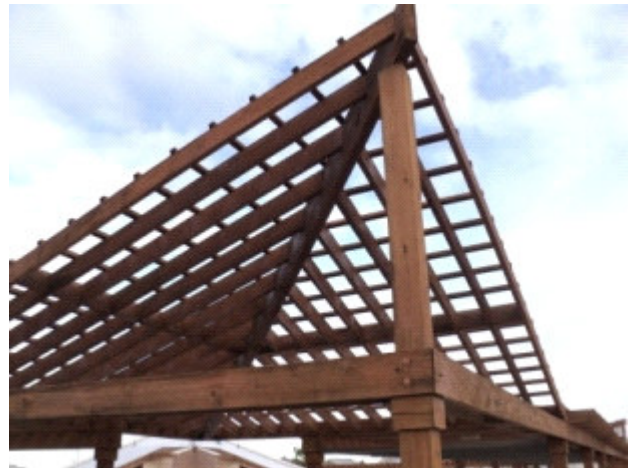
G2. Trellis

Condition: Satisfactory condition with some deterioration and damage noticed. During the site visit, we were told that the trellis was stained in 2008. Some of the components of the trellis were splitting.

- Cyclically repair and stain the trellis every 6 years, starting in 2017.
- Replace the trellis in 2023.

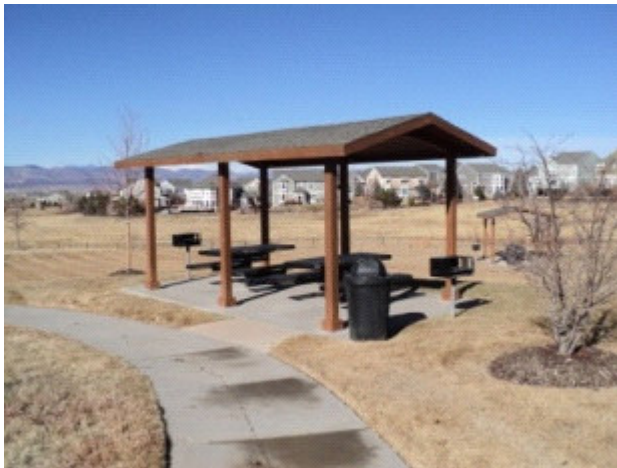
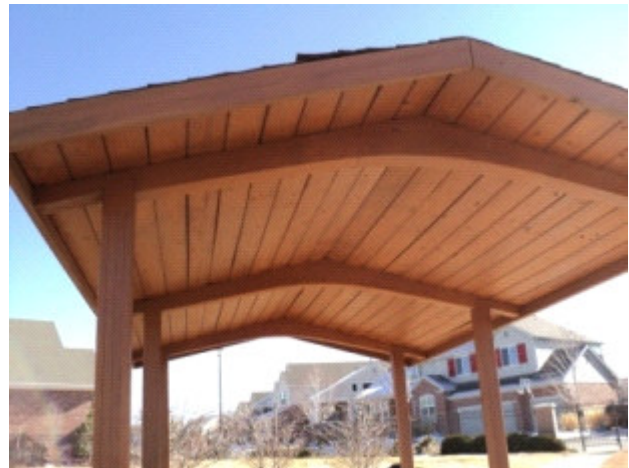
G4. Shelters

Condition: Satisfactory condition with some deterioration and damage noticed. During the site visit, some of the roof decking was twisted and bowed.

- Cyclically repair and stain the shelters every 6 years, starting in 2012. Financial allocation for repairing and staining the shelters is included in component G2 of this Study.
- Replace the shelters in 2024. Financial allocation for replacing the shelters is included in component G2 of this Study.

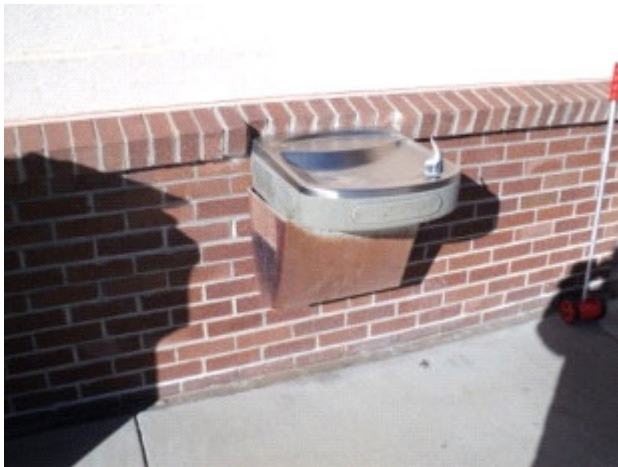
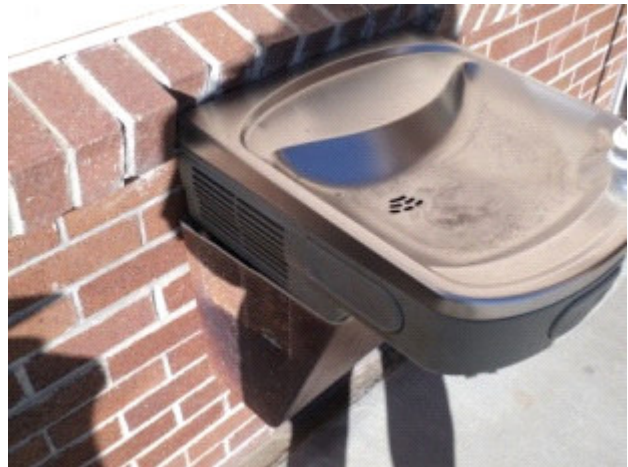
G5. Water Cooler

Condition: Poor condition. During the site visit, the housing surrounding the lower portion of the drinking fountain was corroded and deteriorating due to exposure to the environmental elements.

- Replace the water cooler in 2011. The cost is not included in the Study because it falls below the minimum fund threshold.
